# CPD Article

# Full upper arch rehabilitation

**Helen Horton- Full upper arch rehabilitation**

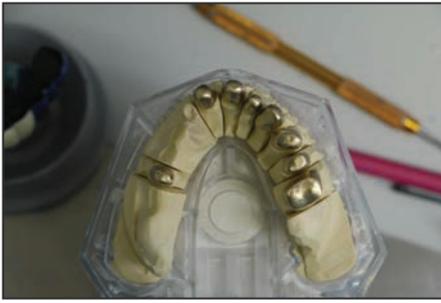
Fig 1: Gold Primary Copings – Occlusal view

In choosing telescopic bridges or dentures, some of the benefits for the patient can be a longer functional period of integrated construction, the simple handling of dentures with double crowns, other benefits include easy cleaning, repairs, extractions or additions in comparison to fixed bridge work. (Figure 1)

The dies were then dipped in a yellow wax which was trimmed to a minimum thickness of 0.3mm. The milling wax was then built by hand using the surveying tools as a guide for the taper. Once cooled the copings were milled using a 2 degree wax bur and reduced to minimum thickness at their thinnest part (yellow wax showing through) ensuring that at least 3.5mm<sup>2</sup> on at least 2 sides and in turn parallel to each other was milled to ensure adequate frictional grip.

The copings were then sprued, invested, burnt out and cast in the normal way using a 60% gold.

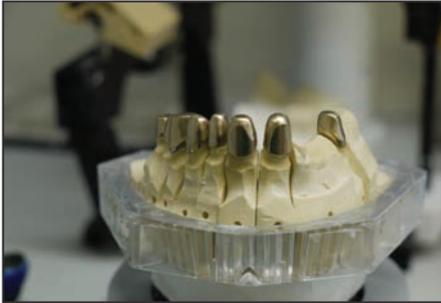
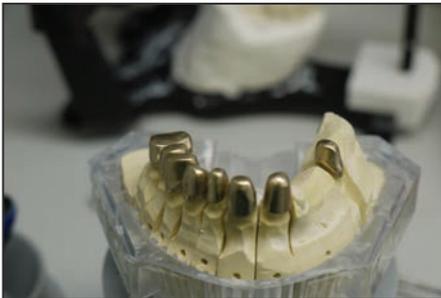
Fig 2 & 3: Gold Primary Crowns – labial view.

Once de-vested and fitted to the dies the occlusal surfaces and collars were ground and polished, then began the time

consuming finishing of the milled surfaces with staged burs to achieve high shine tapered surfaces on all of the primary crowns. (Figures 2 & 3)

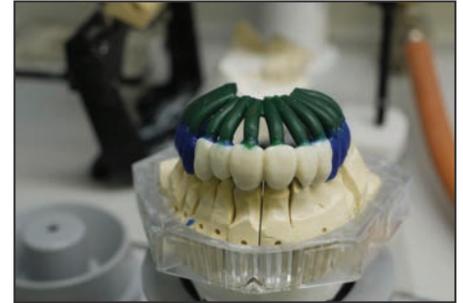
Fig 8: Waxed up and sprued ready for investing.

PoM ceramic, full contour wax ups were then copied from the original diagnostic wax ups using silicone keys and the information transferred onto the metal framework. The occlusion was carefully checked and the sprues attached to the wax frame. (Figures 8 & 9)

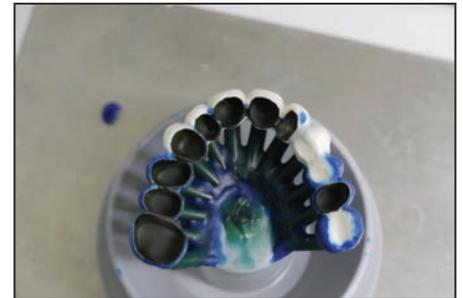
Fig 9 : On investing former.

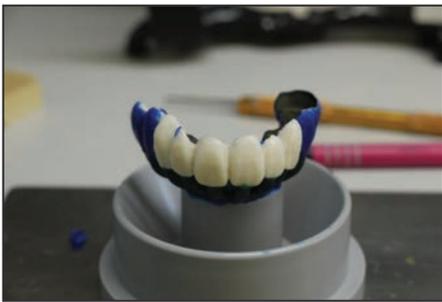
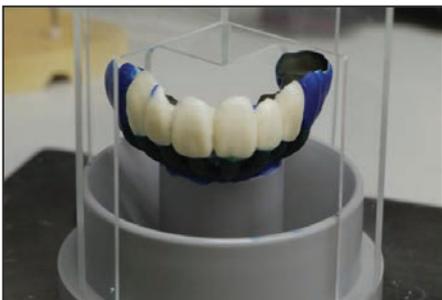
Fig 10 & 11: On former and positioning guide showed bridge was too large for PoM technique.

Once the positioning guide was placed I realised that the restoration was too high in the ring and needed more ceramic than the 6 pellets allowed, which meant I would not be able to proceed with the planned PoM technique.(Figures 10 & 11)

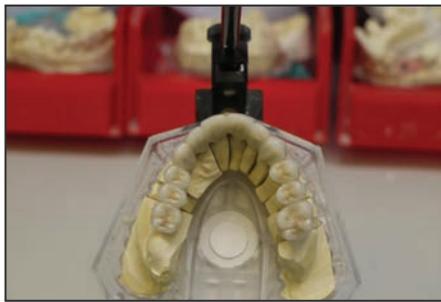
Fig 14: Occlusal view

with Ivoclar IPS d.sign ceramic using traditional veneering techniques. (Figures 12, 13, 14, 15, 16 & 17)

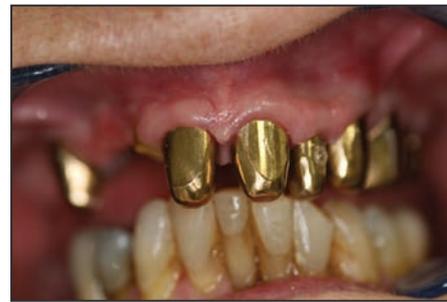
Fig 18: Primary crowns in situ.

to ensure that the patient was happy with the aesthetics and the surgeon happy with the clinical aspect, no adjustments were necessary. After the copings were cemented the bridge was placed using Vaseline allowing a week for any micro movement to occur in the patients' natural dentition prior to cementing with temporary crown cement. There were a couple of areas of slight blanching but this was felt to be acceptable and no adjustments were made. (Figures

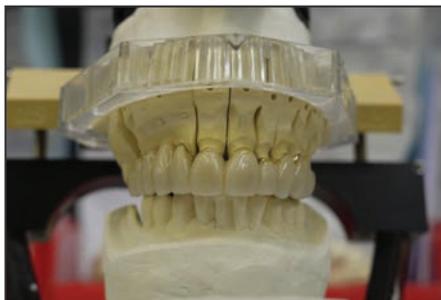
Fig 15: Labial view

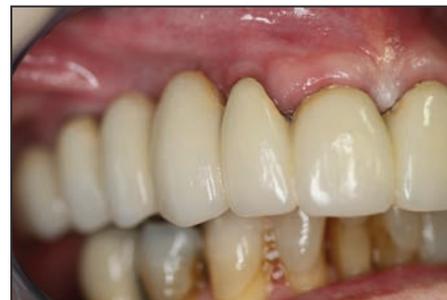
Fig 19: Bridge in place right buccal corridor.

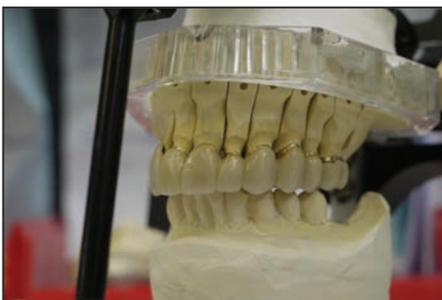
Fig 12: Finished Bridge - built in Ivoclar d.sign 97 porcelain. Left hand view.

The Coron alloy had a favourable CTE to the d.sign ceramic which allowed the bridge to be completed with just three body firings and one glaze firing where small areas of staining were applied to the cervical, interproximal and occlusal surfaces.

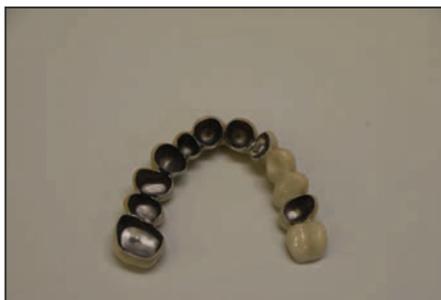
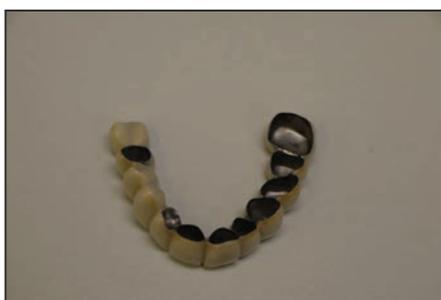
Fig 16 & 17: Fit surface lightly polished with 50 micron glass beads.

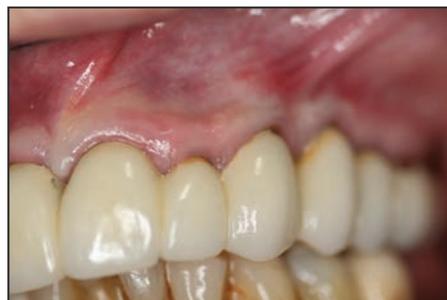
Fig 20: Bridge in place left buccal corridor.

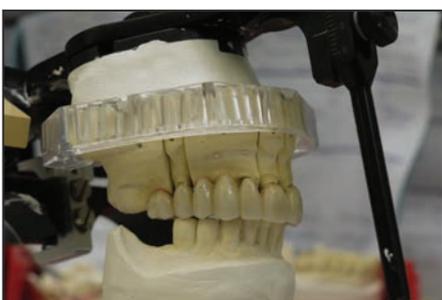
Fig 13: Right hand view

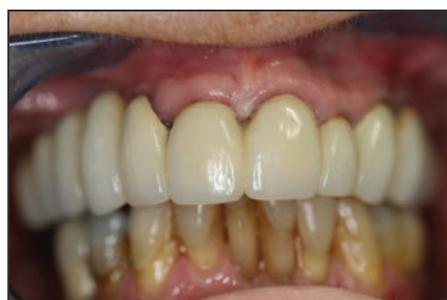
Fig 21: Labial view.

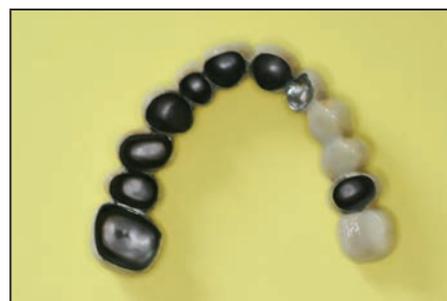
Fig 22: Fit surface 1 year later showing no sign of wear or tight spots

The small gold collars that had been visible 1 year earlier were now not showing due to her improved gum condition. The improved gum condition had been as a result of easy and thorough cleaning by the patient and the exceptional fit of the primary copings and telescopic bridge. The

milled fit surface was also smoother than any cast surface and so was not causing any wear to the gold primary copings allowing Helen to continue removing the bridge at her convenience. (Figure 22 & 23)
